SAFETY AUDIT DATA TO STRENGTHEN HANOI METRO LINE 3

Hanoi Metro Line 3

Safety Audits of Hanoi Metro Line 3

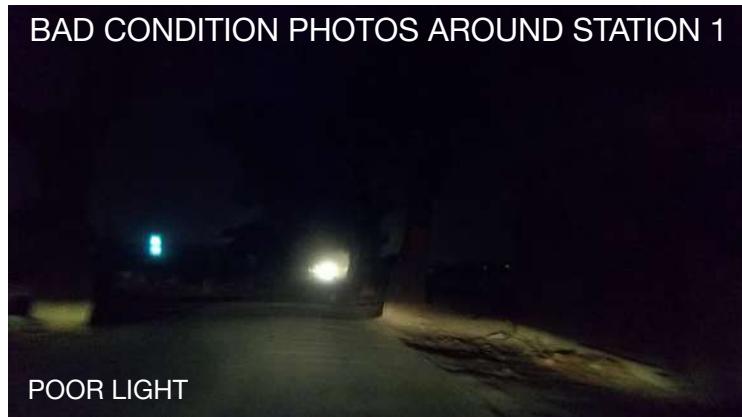
POOR LIGHT

The first row of images here illustrate the quality of the street lighting after nightfall – both of good and poor condition. The second row shows the quality of the sidewalks, the third row shows how visible are people on the streets by others and the fourth row shows the gender diversity of the crowd present after dark. These together with five more parameters (refer Safetipin rubric on page 00) help to collect safety related information of the urban environment.

Recommendation: Street lights as mapped within the zone to be fixed and consequently checked for uniformly lighting up the streets without leaving any dark patches in order to make the entire surrounding clearly visible. Well light street is the top most important factor which adds positively towards the perception of safety.

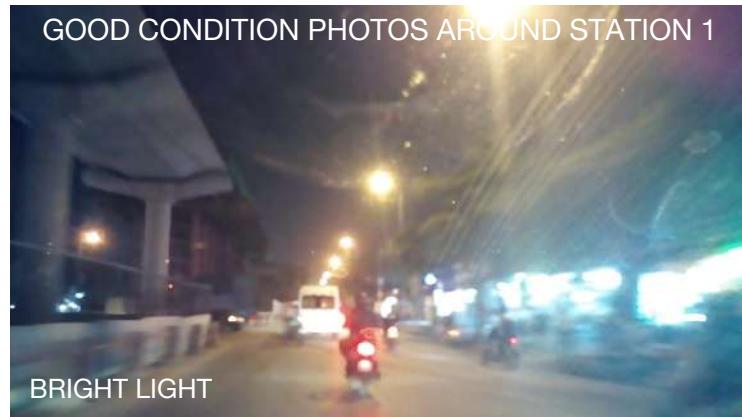
BRIGHT LIGHT

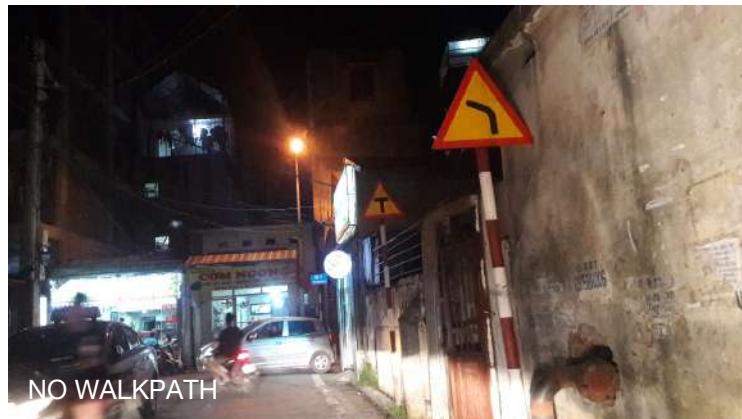
NO WALKPATH

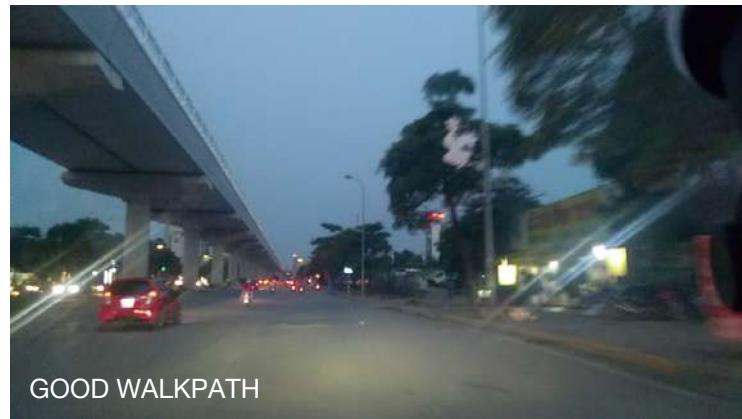
GOOD WALKPATH

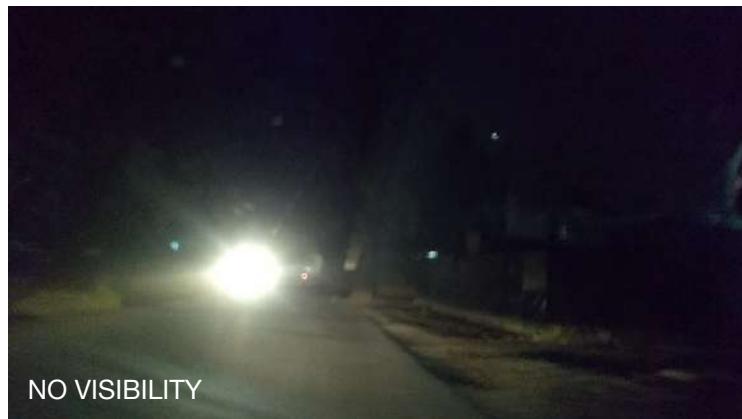
NO VISIBILITY

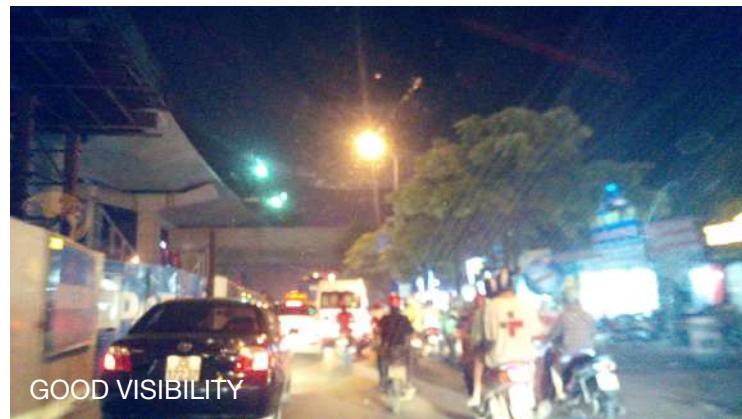
GOOD VISIBILITY

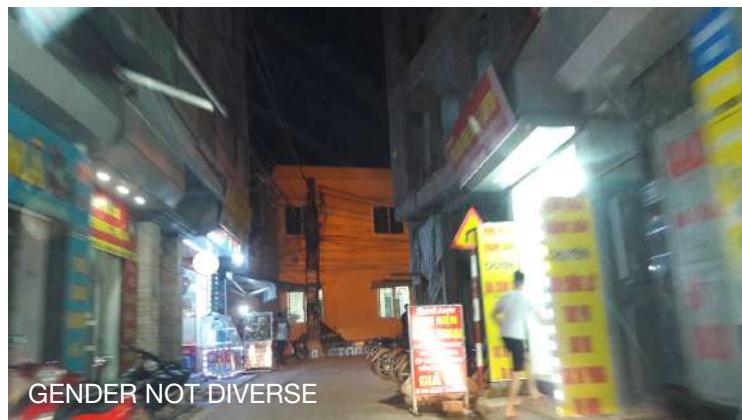
GENDER NOT DIVERSE

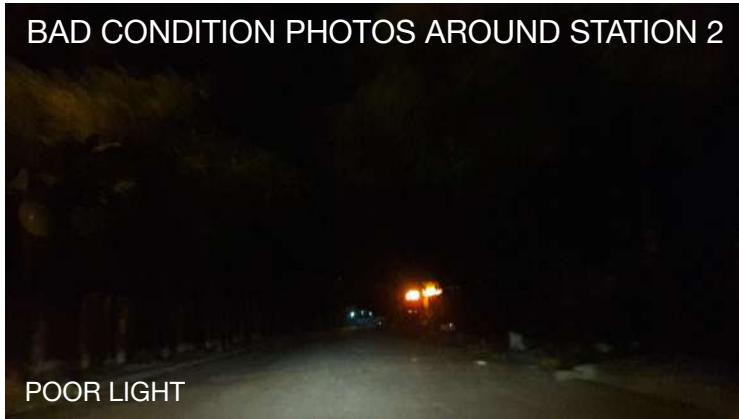
POOR LIGHT

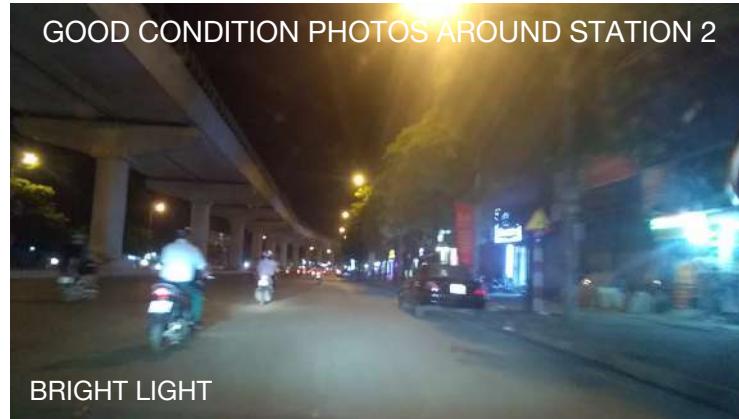
BRIGHT LIGHT

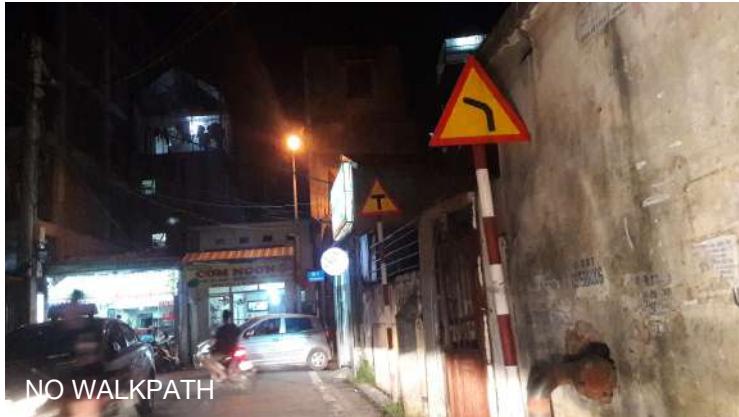
NO WALKPATH

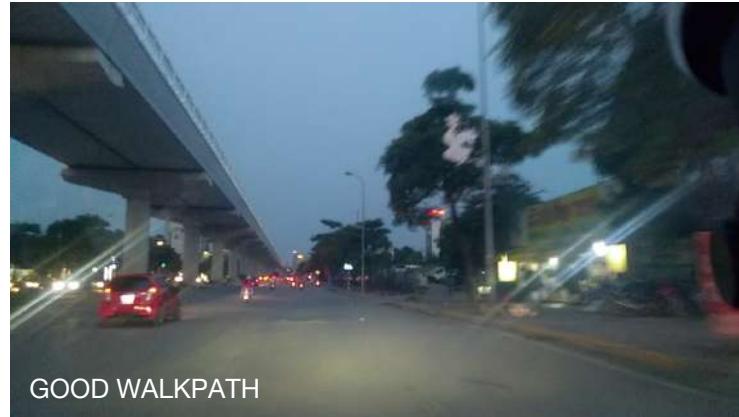
GOOD WALKPATH

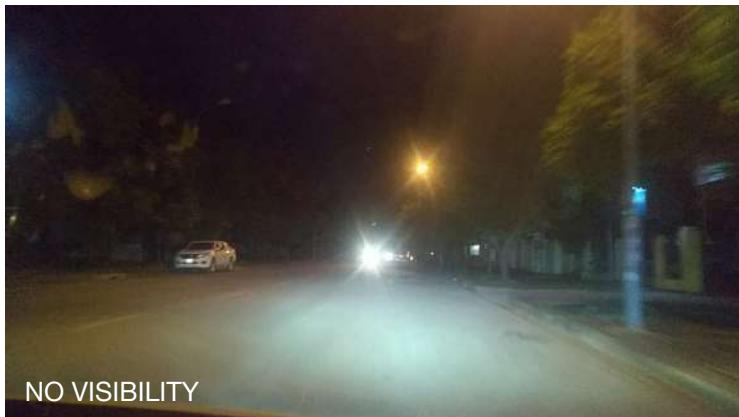
NO VISIBILITY

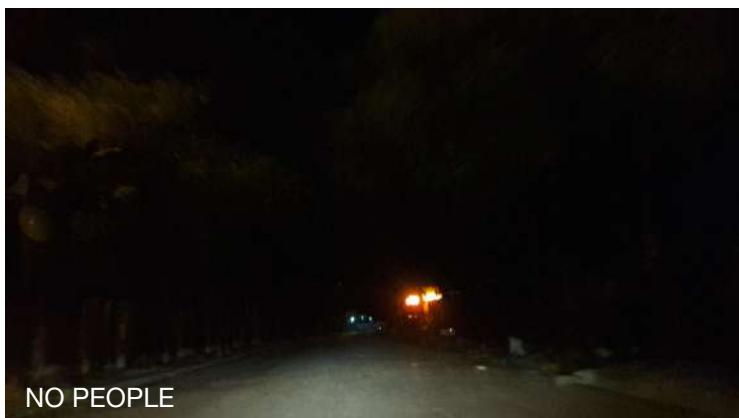
NO PEOPLE

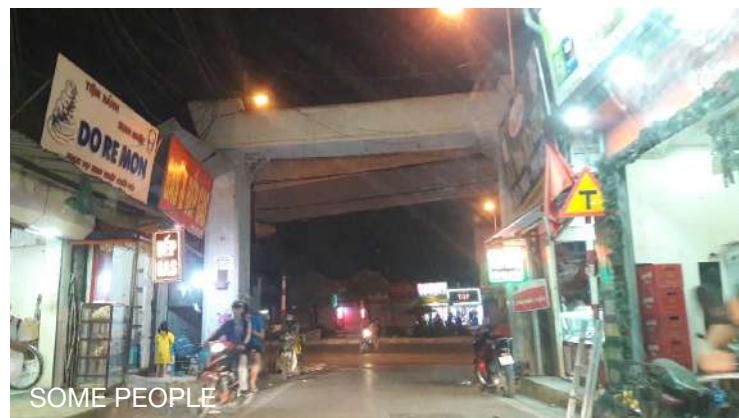
SOME PEOPLE

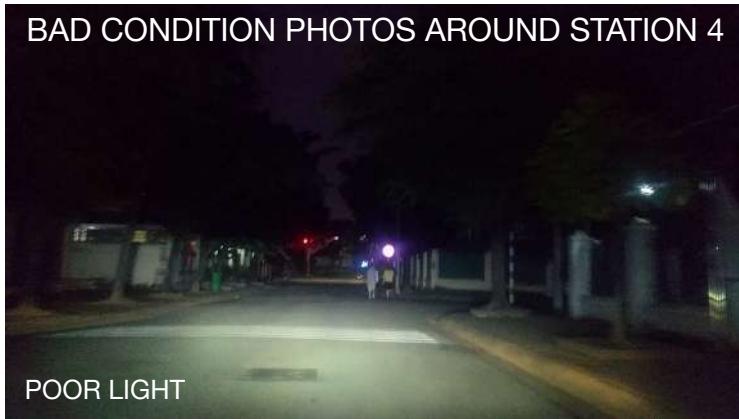
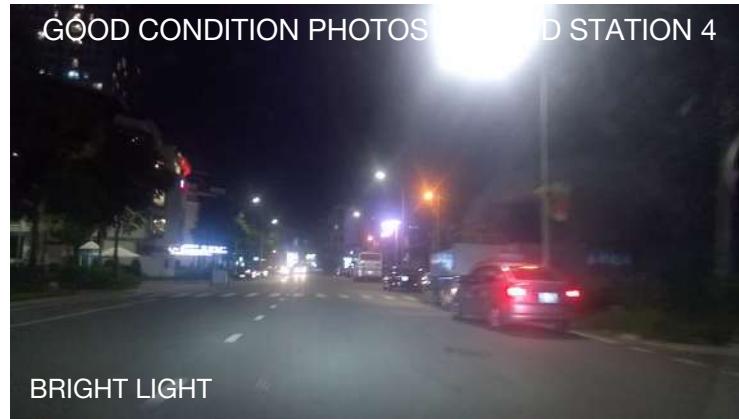
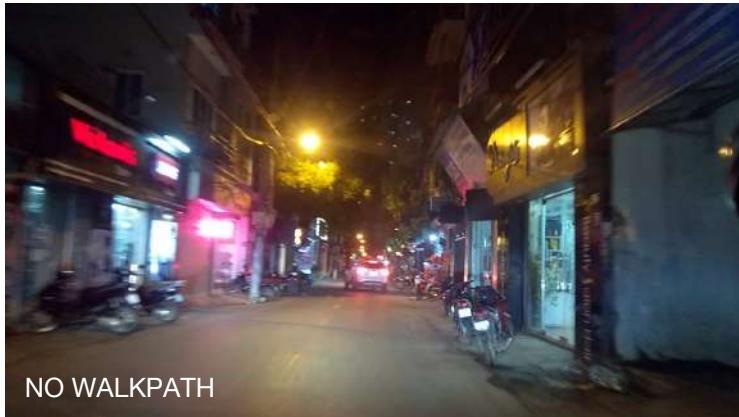
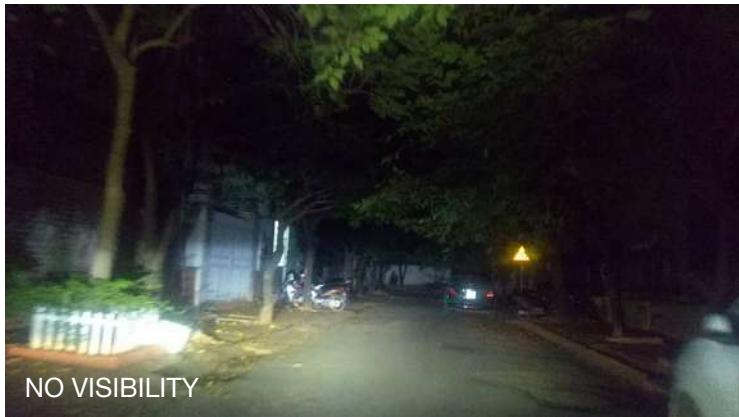
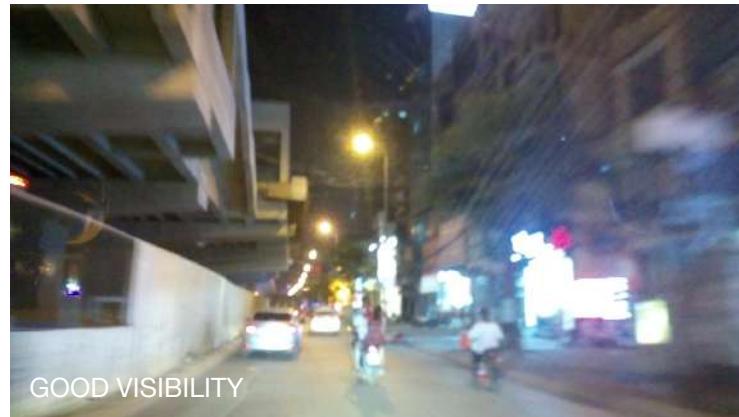
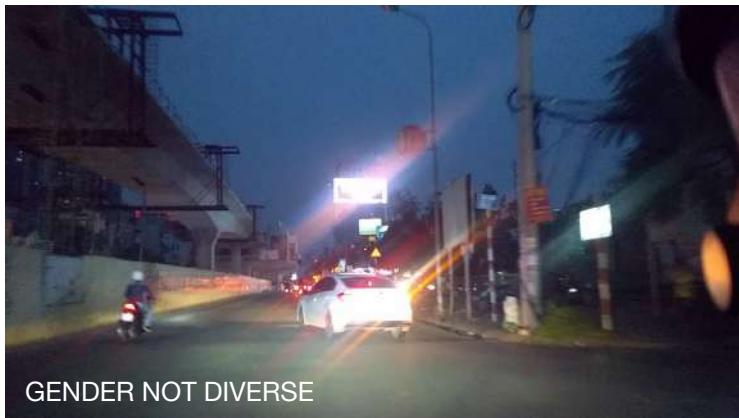
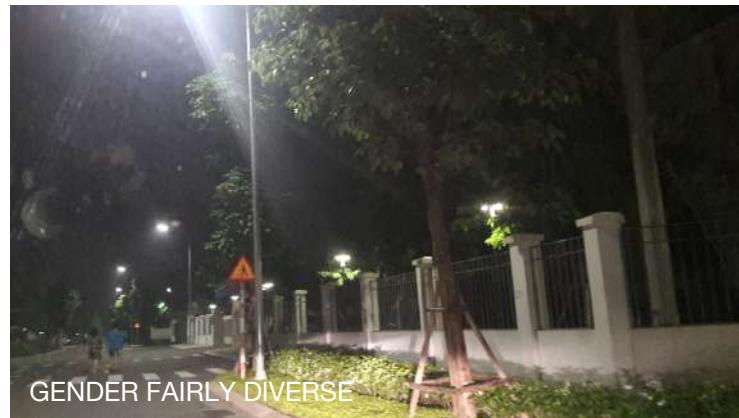
BAD CONDITION PHOTOS AROUND STATION 4

109 Audit Pins within 500m radius of Cau Dien Station

A total of 109 audit pins were generated by the volunteers using 'My Safetipin' app and by the hired vehicles using 'Safetipin Nite' app. The images shown on the left are from these audits used here to highlight the condition of the physical and social parameters considered for evaluating the area around Station No. 4 of Hanoi Metro Line 3.

The first row of images here illustrate the quality of the street lighting after nightfall – both of good and poor condition. The second row shows the quality of the sidewalks, the third row shows how visible are people on the streets by others and the fourth row shows the gender diversity of the crowd present after dark. These together with five more parameters (refer Safetipin rubric on page 00) help to collect safety related information of the urban environment.

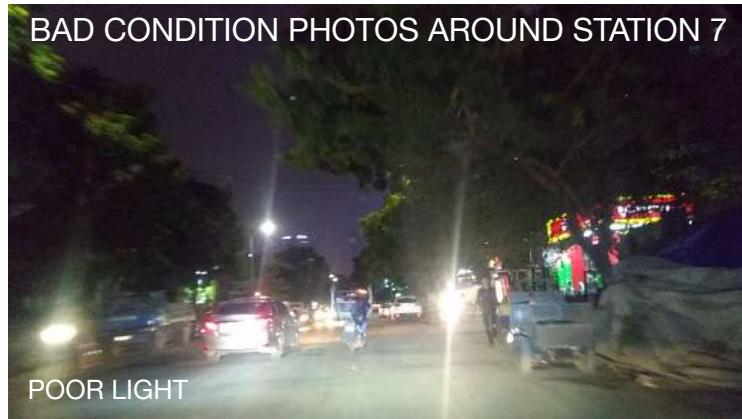
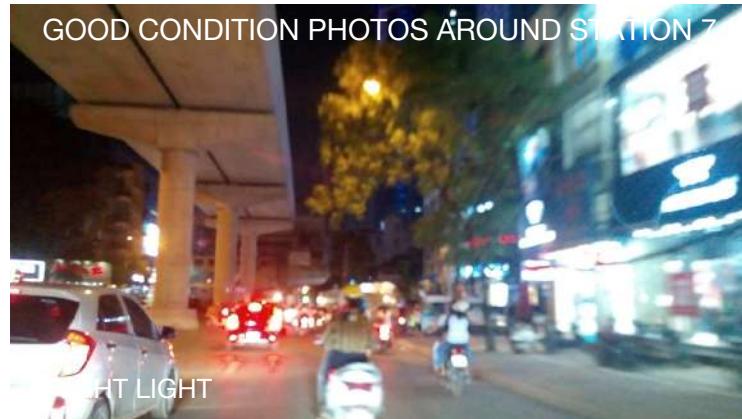
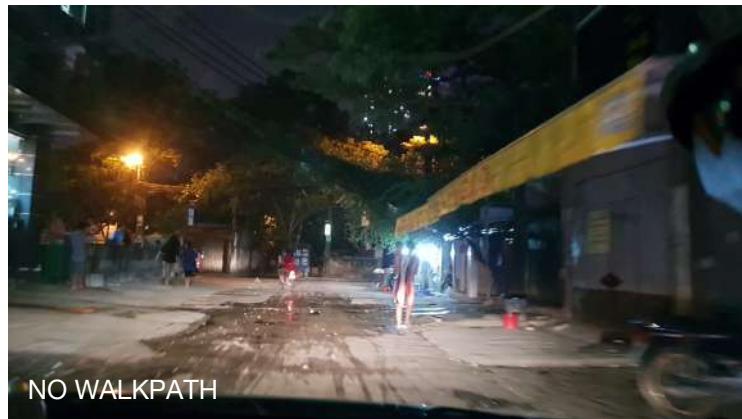
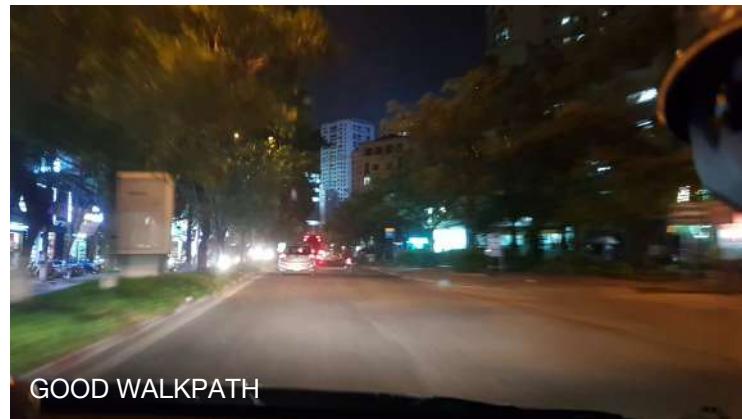
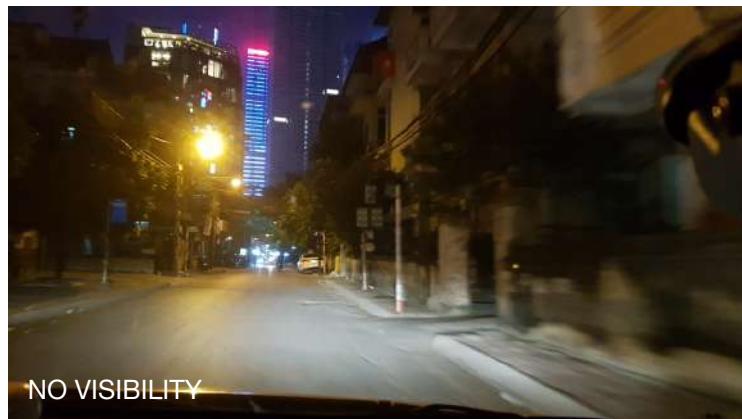
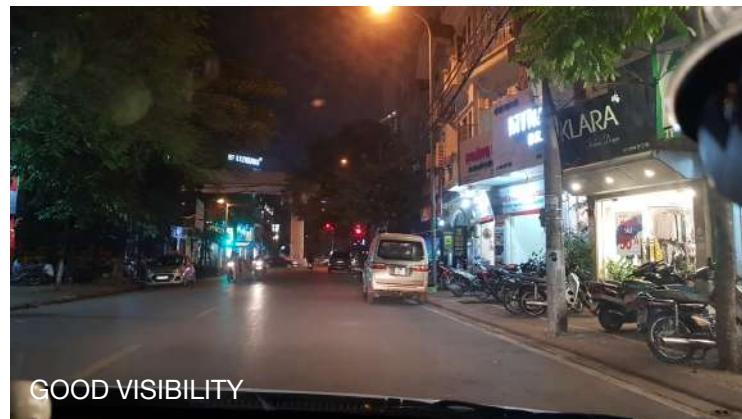
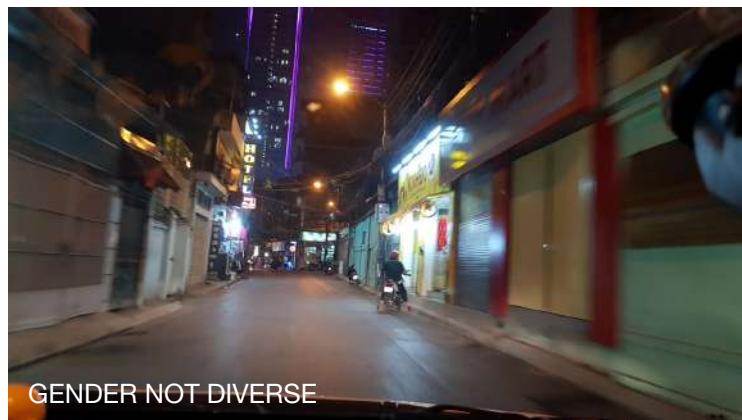
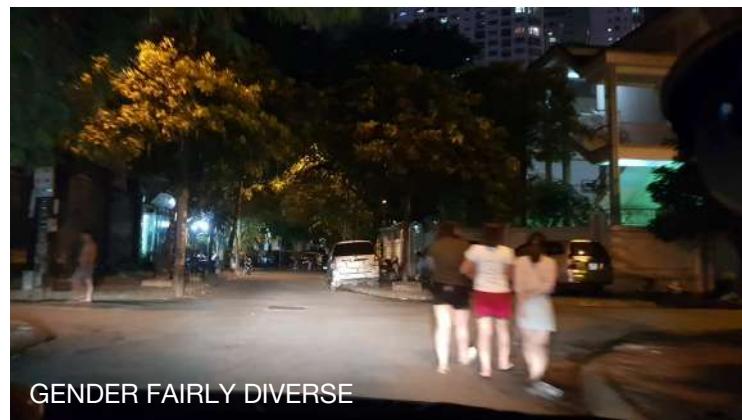
139 Audit Pins within 500m radius of Chua Ha Station

A total of 139 audit pins were generated by the volunteers using 'My Safetipin' app and by the hired vehicles using 'Safetipin Nite' app. The images shown on the left are from these audits used here to highlight the condition of the physical and social parameters considered for evaluating the area around Station No. 7 of Hanoi Metro Line 3.

The first row of images here illustrate the quality of the street lighting after nightfall – both of good and poor condition. The second row shows the quality of the sidewalks, the third row shows how visible are people on the streets by others and the fourth row shows the gender diversity of the crowd present after dark. These together with five more parameters (refer Safetipin rubric on page 00) help to collect safety related information of the urban environment.

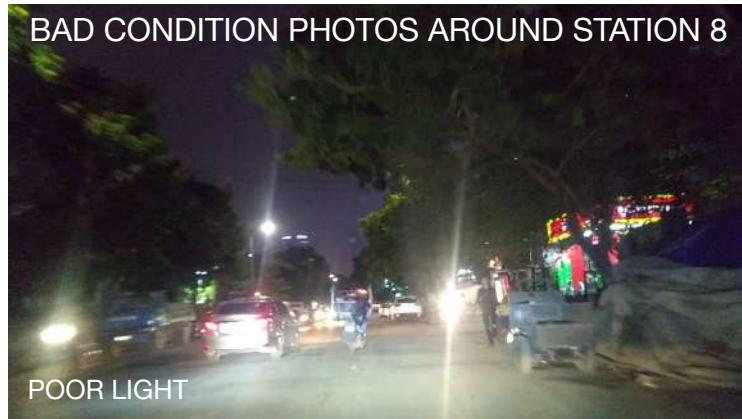
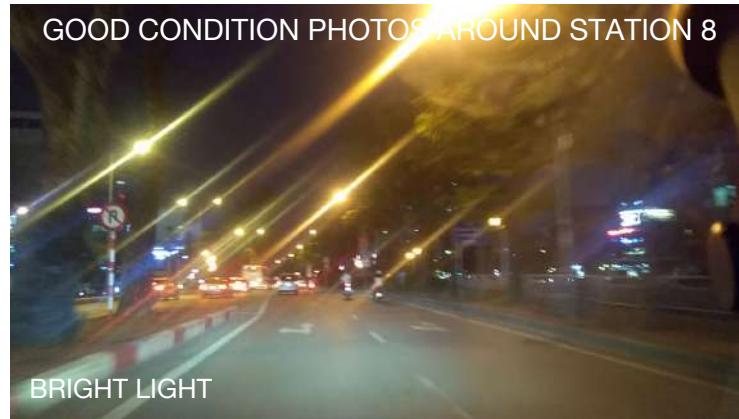
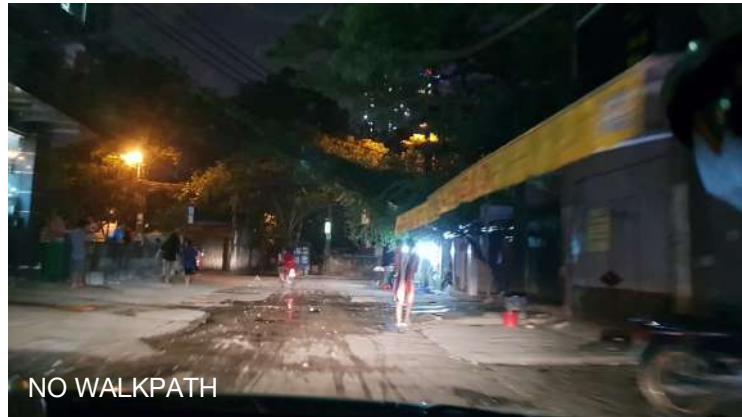
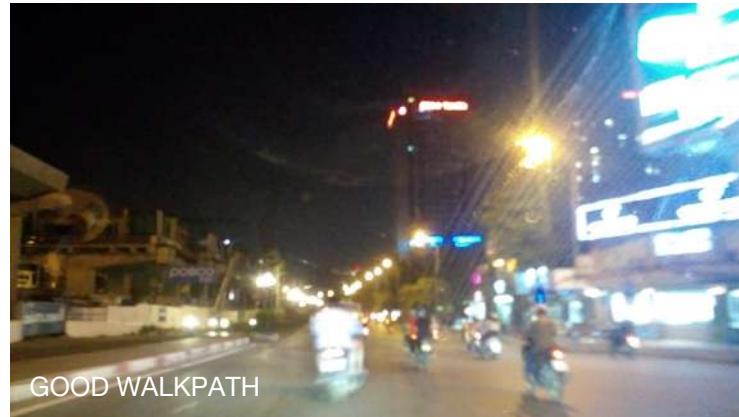
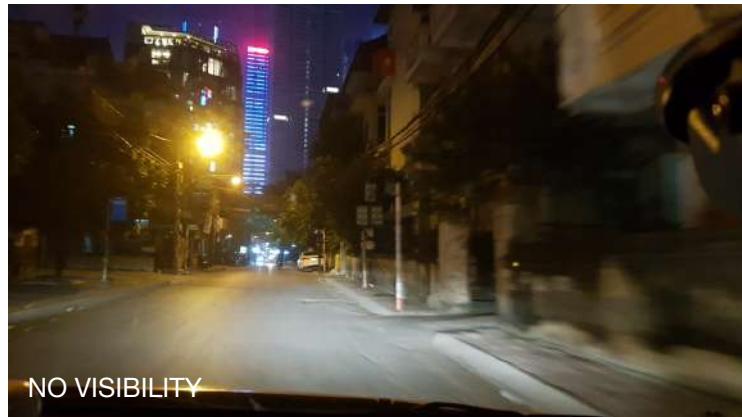
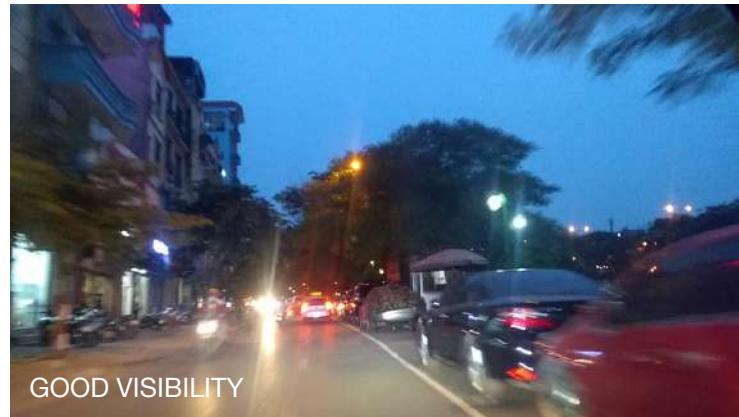
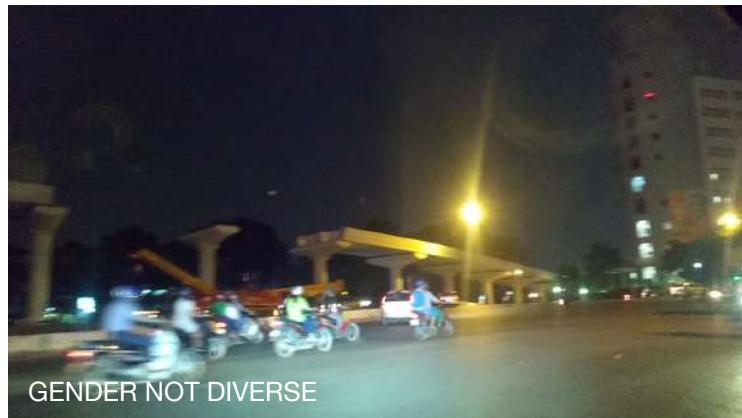
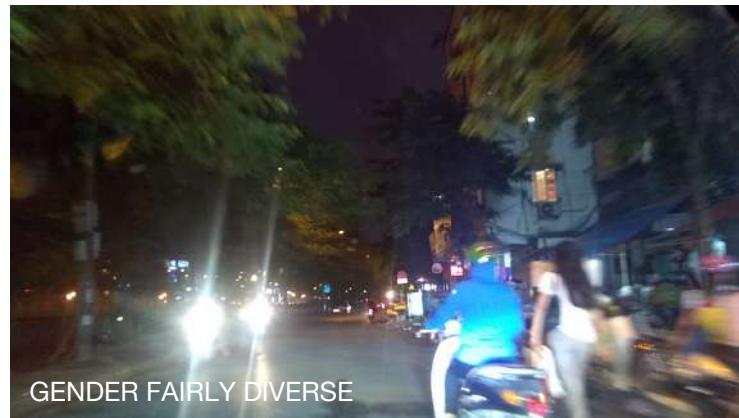
108 Audit Pins within 500m radius of Cau Giay Station

A total of 108 audit pins were generated by the volunteers using 'My Safetipin' app and by the hired vehicles using 'Safetipin Nite' app. The images shown on the left are from these audits used here to highlight the condition of the physical and social parameters considered for evaluating the area around Station No. 8 of Hanoi Metro Line 3.

The first row of images here illustrate the quality of the street lighting after nightfall – both of good and poor condition. The second row shows the quality of the sidewalks, the third row shows how visible are people on the streets by others and the fourth row shows the gender diversity of the crowd present after dark. These together with five more parameters (refer Safetipin rubric on page 00) help to collect safety related information of the urban environment.

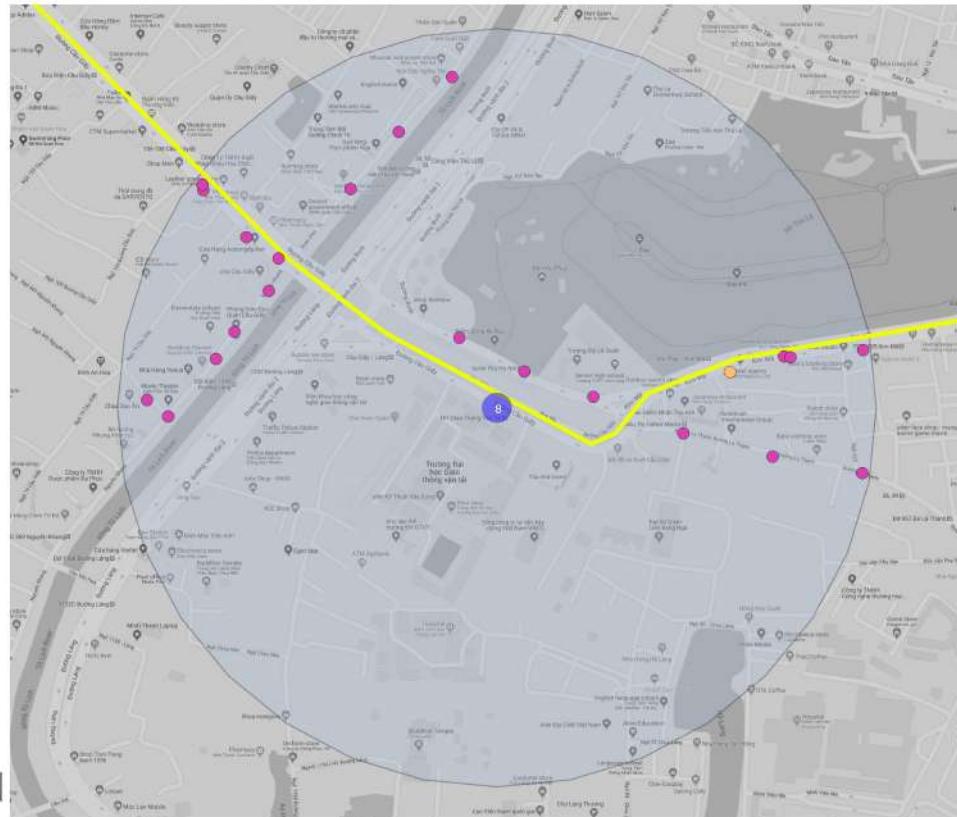
Map on the left above: showing points for pavements which are within the 500 meter radius of the metro station and are either missing, broken or blocked with/encroached upon currently.

Recommendation: Walkpaths as mapped within the zone to be fixed and consequently checked for blockages due to bikes and cars parked on them or for encroachments by small shops and informal businesses. Pedestrian walkpaths must be clear of any hindrances and the route ahead clearly visible. Well maintained walkpaths improve walkability and increase accessibility for pedestrians.

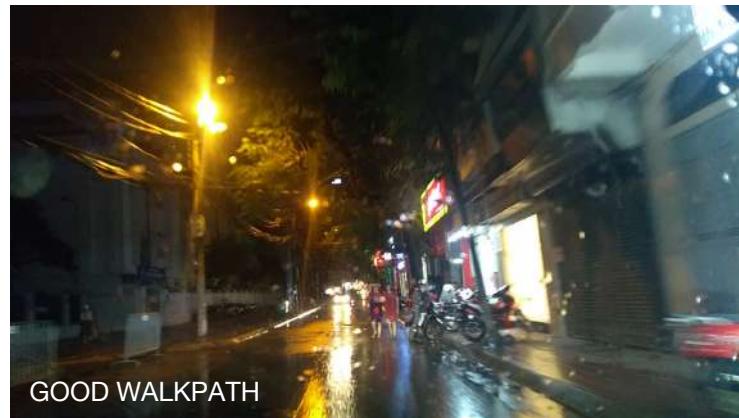
NO WALKPATH

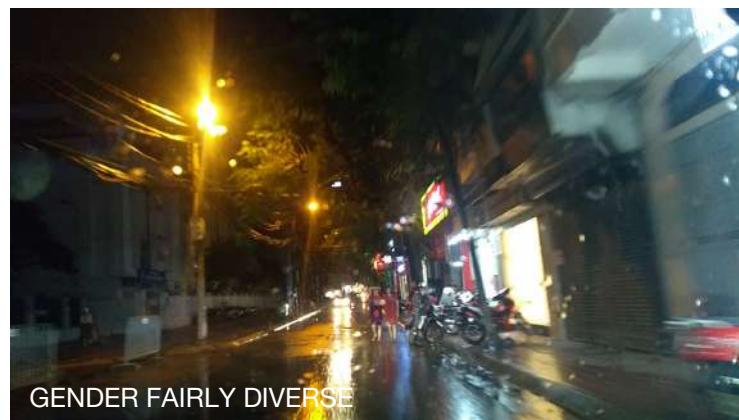
GENDER NOT DIVERSE

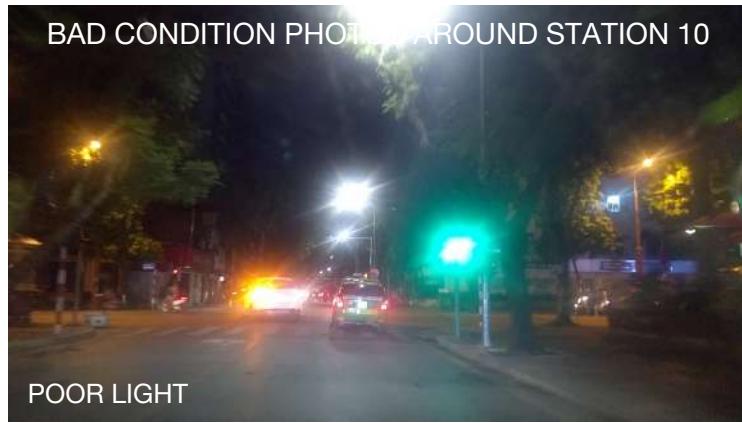
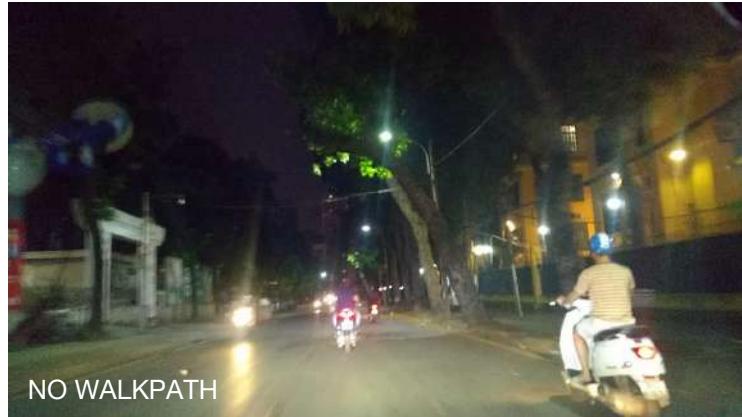
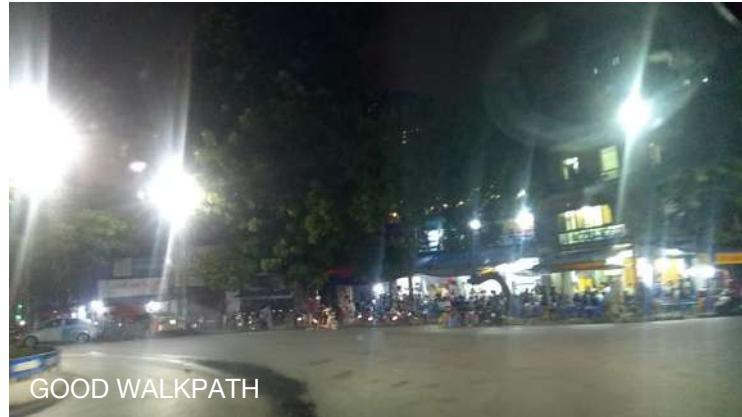
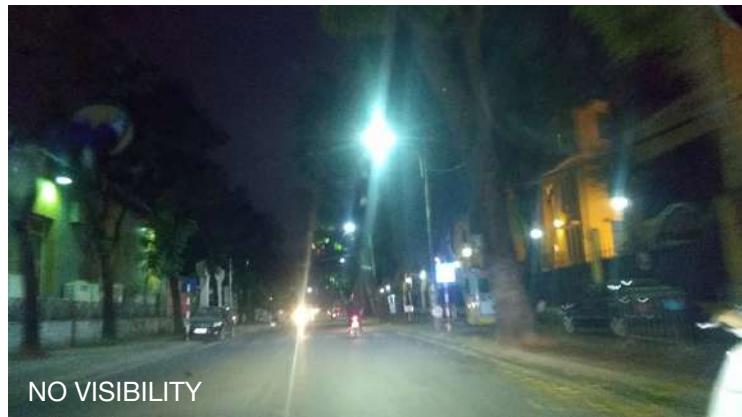
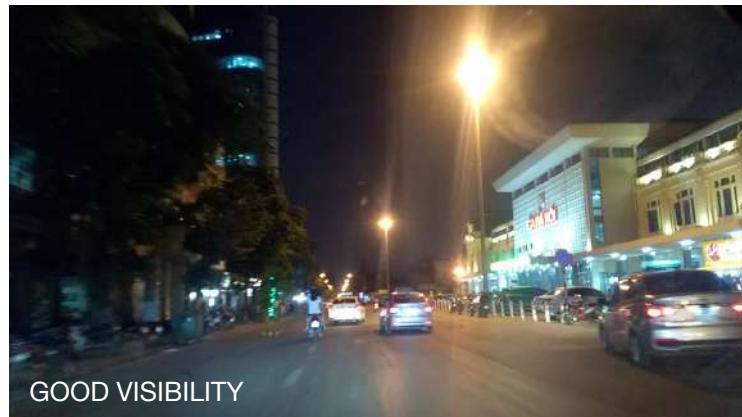
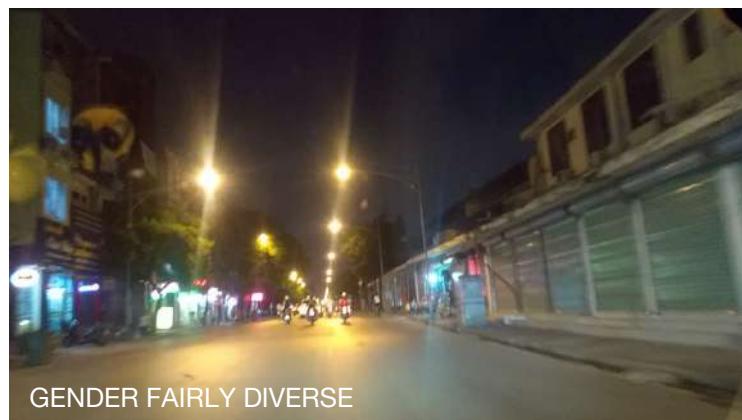
149 Audit Pins within 500m radius of Cat Linh Station

A total of 149 audit pins were generated by the volunteers using 'My Safetipin' app and by the hired vehicles using 'Safetipin Nite' app. The images shown on the left are from these audits used here to highlight the condition of the physical and social parameters considered for evaluating the area around Station No. 10 of Hanoi Metro Line 3.

The first row of images here illustrate the quality of the street lighting after nightfall – both of good and poor condition. The second row shows the quality of the sidewalks, the third row shows how visible are people on the streets by others and the fourth row shows the gender diversity of the crowd present after dark. These together with five more parameters (refer Safetipin rubric on page 00) help to collect safety related information of the urban environment.

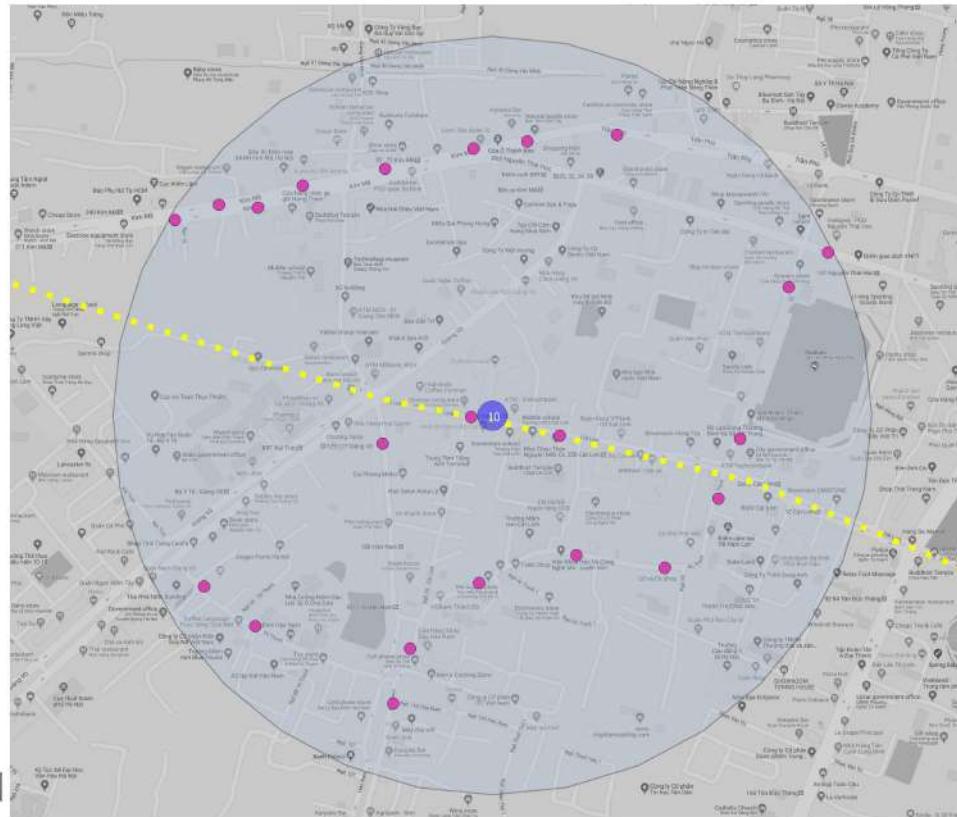
Map on the left above: showing points for pavements which are within the 500 meter radius of the metro station and are either missing, broken or blocked with/encroached upon currently.

Recommendation: Walkpaths as mapped within the zone to be fixed and consequently checked for blockages due to bikes and cars parked on them or for encroachments by small shops and informal businesses. Pedestrian walkpaths must be clear of any hindrances and the route ahead clearly visible. Well maintained walkpaths improve walkability and increase accessibility for pedestrians.

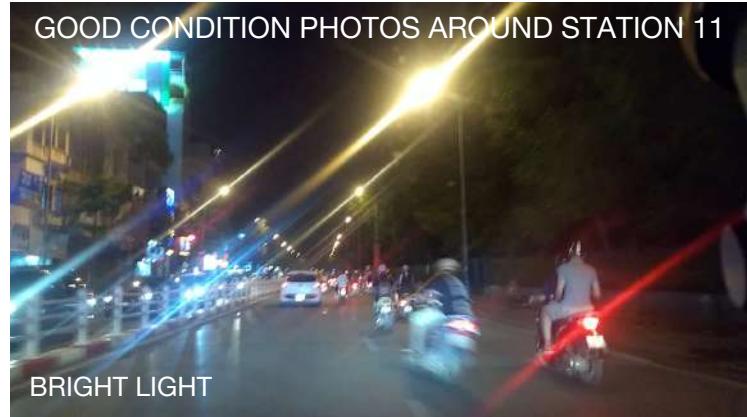
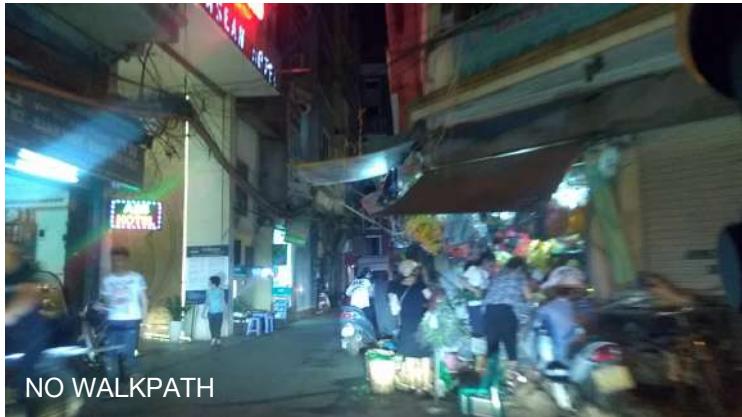
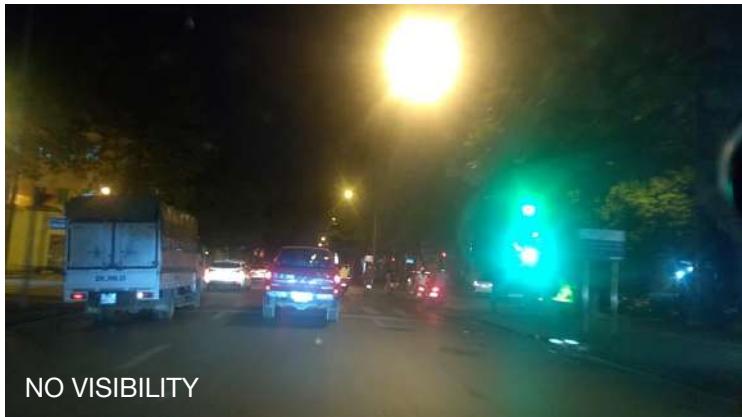
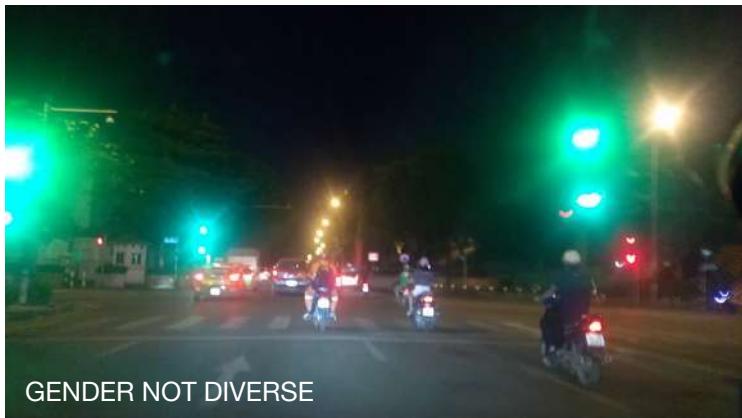
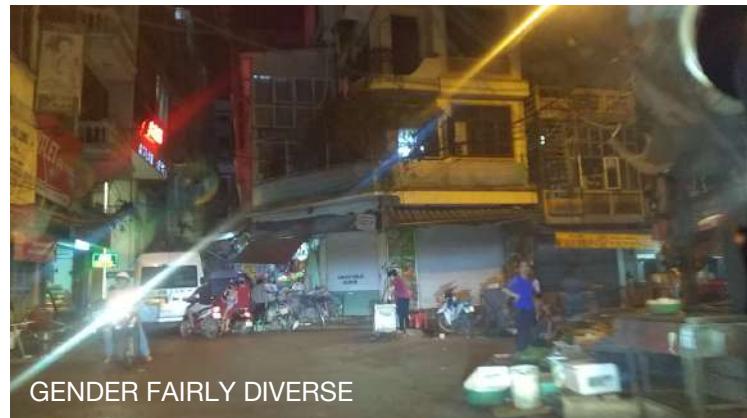
116 Audit Pins within 500m radius of Van Mieu Station

A total of 116 audit pins were generated by the volunteers using 'My Safetipin' app and by the hired vehicles using 'Safetipin Nite' app. The images shown on the left are from these audits used here to highlight the condition of the physical and social parameters considered for evaluating the area around Station No. 11 of Hanoi Metro Line 3.

The first row of images here illustrate the quality of the street lighting after nightfall – both of good and poor condition. The second row shows the quality of the sidewalks, the third row shows how visible are people on the streets by others and the fourth row shows the gender diversity of the crowd present after dark. These together with five more parameters (refer Safetipin rubric on page 00) help to collect safety related information of the urban environment.

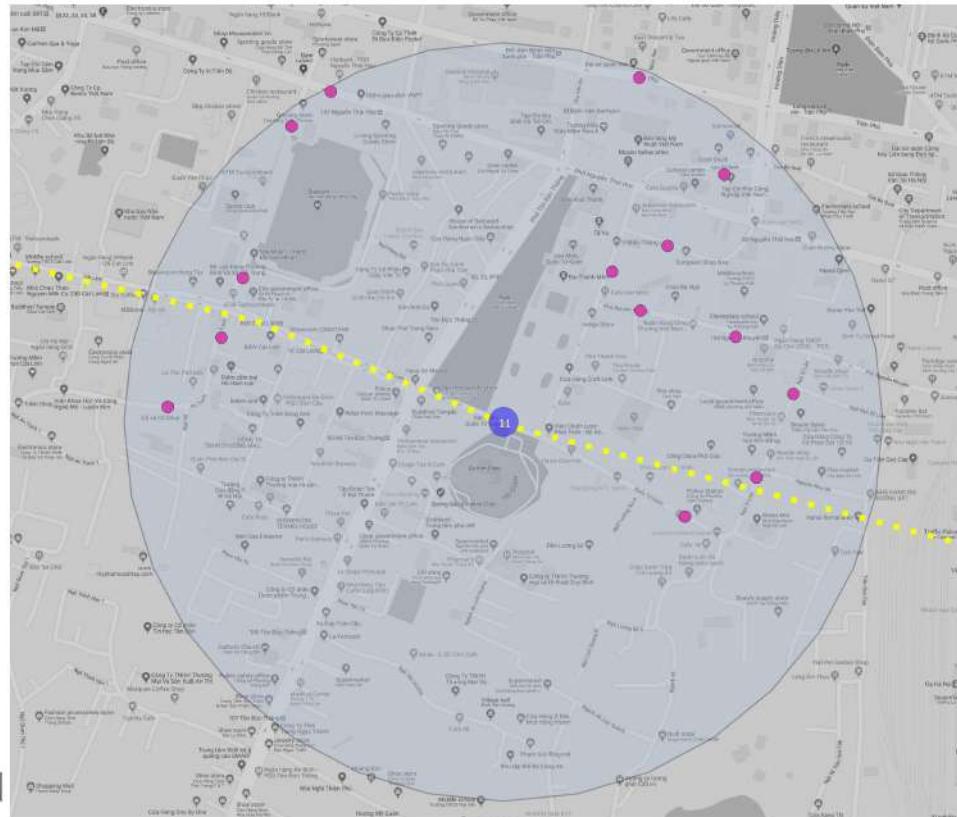
Map on the left above: showing points for pavements which are within the 500 meter radius of the metro station and are either missing, broken or blocked with/encroached upon currently.

Recommendation: Walkpaths as mapped within the zone to be fixed and consequently checked for blockages due to bikes and cars parked on them or for encroachments by small shops and informal businesses. Pedestrian walkpaths must be clear of any hindrances and the route ahead clearly visible. Well maintained walkpaths improve walkability and increase accessibility for pedestrians.

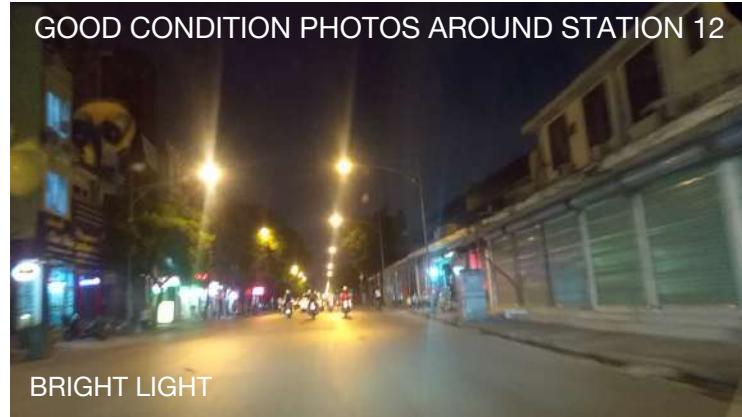
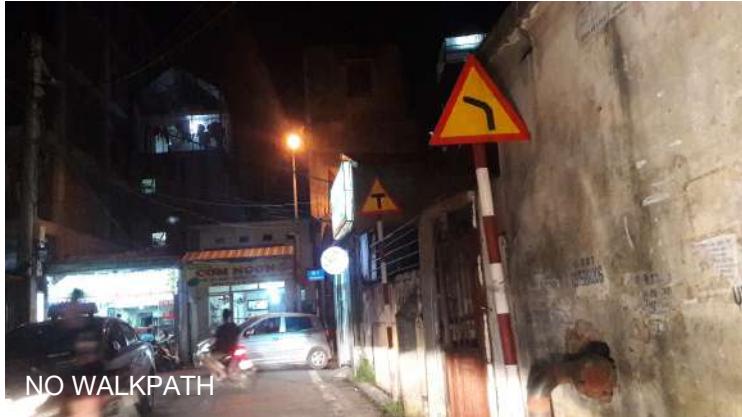
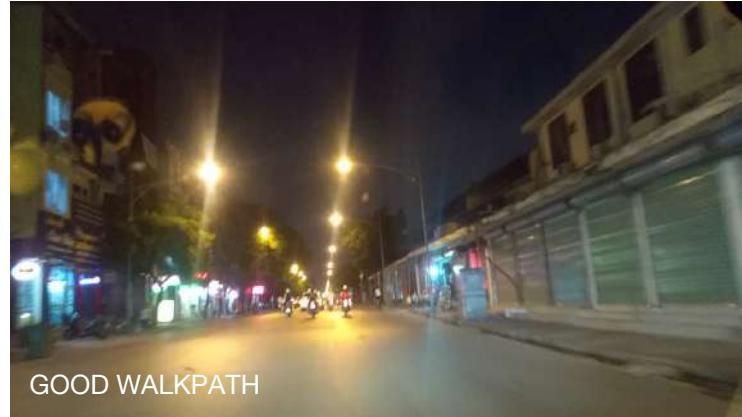
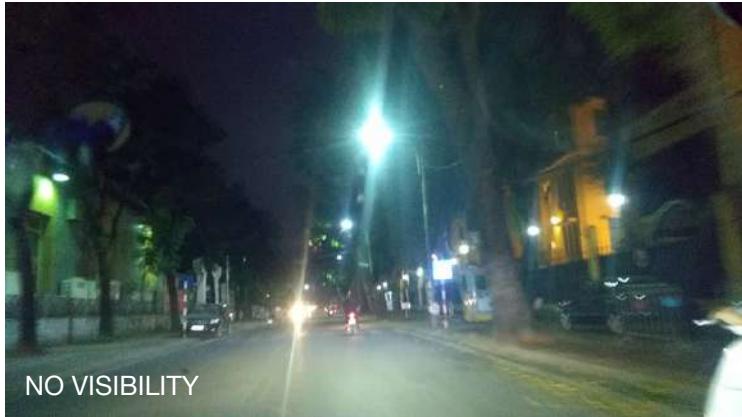
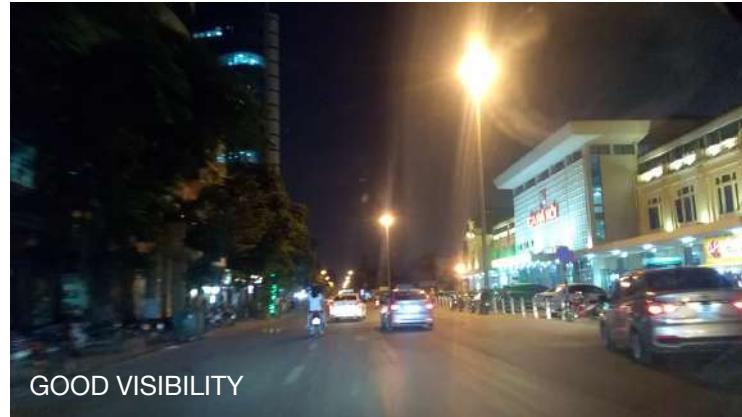
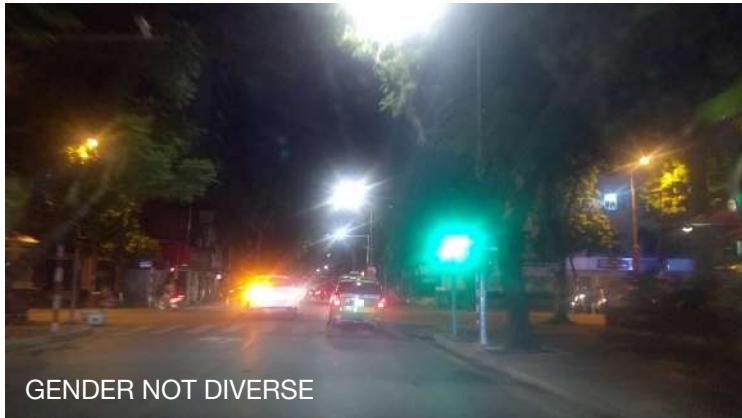
128 Audit Pins within 500m radius of Hanoi Railway Station

A total of 128 audit pins were generated by the volunteers using 'My Safetipin' app and by the hired vehicles using 'Safetipin Nite' app. The images shown on the left are from these audits used here to highlight the condition of the physical and social parameters considered for evaluating the area around Station No. 12 of Hanoi Metro Line 3.

The first row of images here illustrate the quality of the street lighting after nightfall – both of good and poor condition. The second row shows the quality of the sidewalks, the third row shows how visible are people on the streets by others and the fourth row shows the gender diversity of the crowd present after dark. These together with five more parameters (refer Safetipin rubric on page 00) help to collect safety related information of the urban environment.

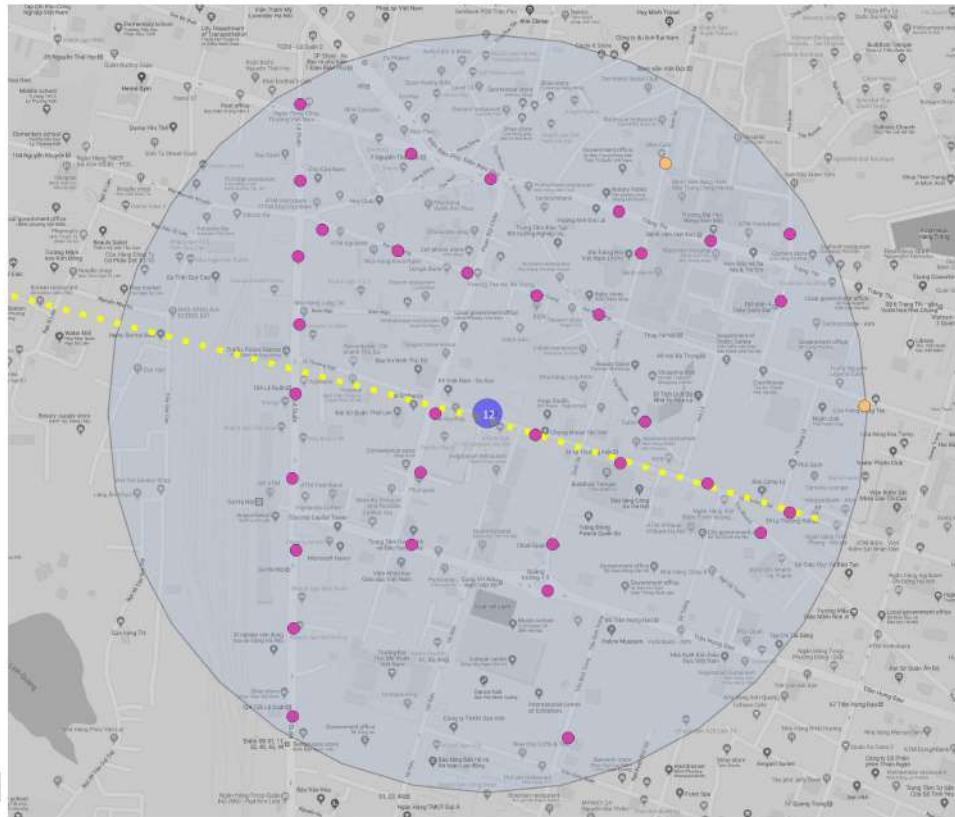
Map on the left above: showing points for pavements which are within the 500 meter radius of the metro station and are either missing, broken or blocked with/encroached upon currently.

Recommendation: Walkpaths as mapped within the zone to be fixed and consequently checked for blockages due to bikes and cars parked on them or for encroachments by small shops and informal businesses. Pedestrian walkpaths must be clear of any hindrances and the route ahead clearly visible. Well maintained walkpaths improve walkability and increase accessibility for pedestrians.
