# SAFETY AUDIT REPORT COLOMBO

**SAFETIP**  
Supporting Safer Cities

As a part of the Safe and Inclusive Cities Initiative under The Metro Colombo Transformation Platform, the World Bank engaged [Safetipin](#) to evaluate the public spaces of Colombo city and suggest recommendations to make them safer. Safetipin uses apps and technology platform to collect data to measure safety and inclusivity of public spaces in cities. At the core of the Safetipin apps is the safety audit, based on 9 parameters Lighting, Openness, Visibility, People Security, Walkpath, Availability of Public Transport, Gender Usage and Feeling. For this study, Safetipin used two of its applications i.e. My Safetipin and Safetipin Nite, to map the city by conducting safety audits. The audits were conducted in the five council areas of Colombo District i.e. Colombo Municipal corporation area, Sri Jayewardenepura Kotte Municipal council area, Kolonnawa Urban Council area, Dehiwala-Mount Lavinia Municipal Council area, and Moratuwa Municipal Council area. In total 7,663 safety audits were generated, and the collected data was analyzed to highlight key issues related to safety and mobility in each of the council are

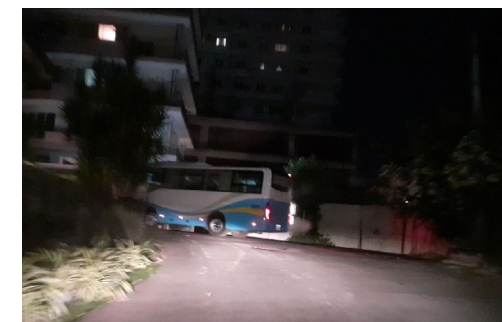
Image 8 showing dark spots on Anula road

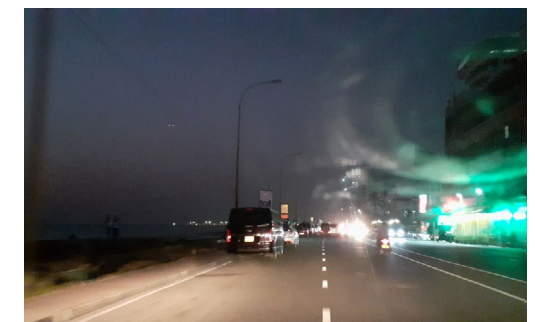
Image 9 showing non functional street lights on Marine Drive road

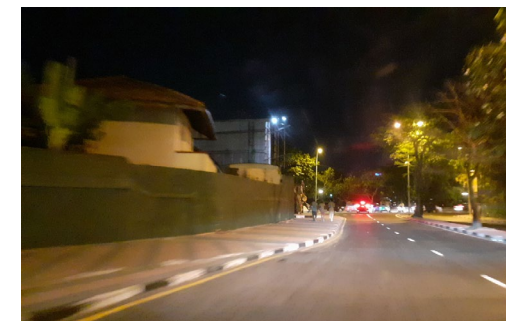
Image 10 showing good walkpath on Jinarathan Road

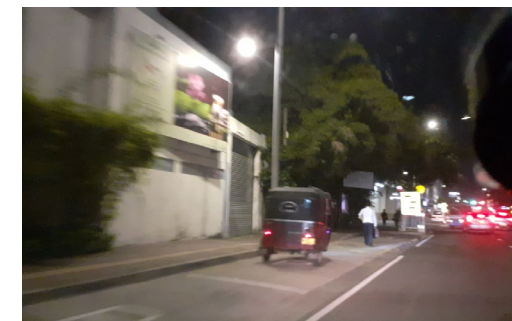
Image 11 showing paved pedestrian path on pedestrians on R.A. De Mel Mawatha Road

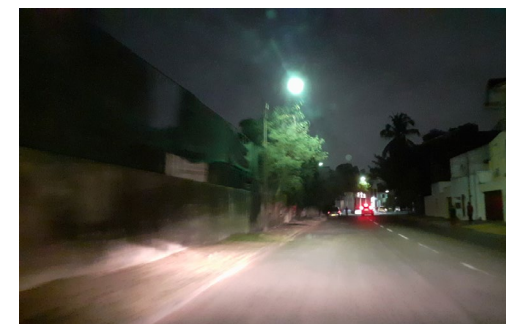
Image 12 showing unpaved pedestrian path on Chitra Lane

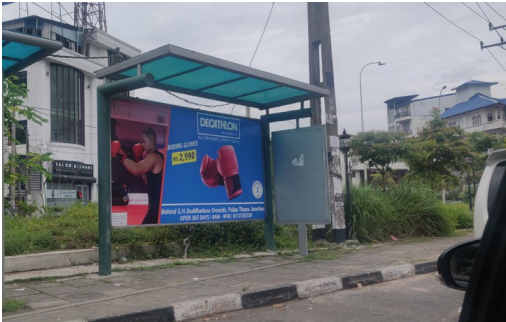
Image 14 showing a bus stop with shelter

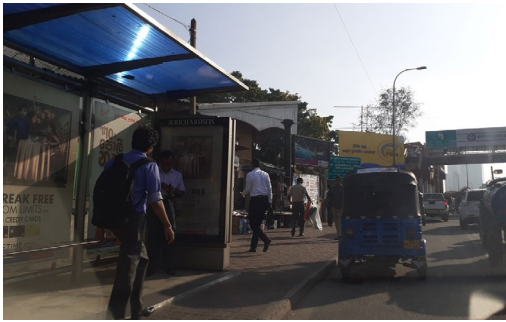
Image 15 showing a bus stop with shelter in CMC area

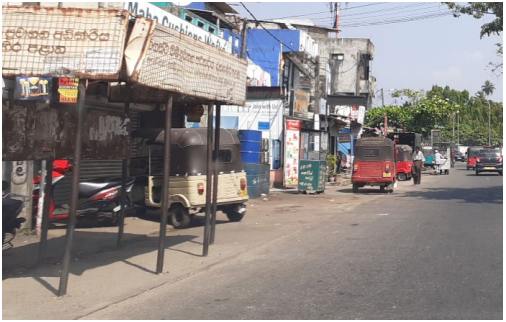
Image 17 showing a bus stop without any seating area

Public Transport refers to the ease of accessing any mode of public transport i.e. rail/bus/taxi/three wheeler etc. and is measured in terms of the distance to the nearest mode. 72% of the area has public transport stands within 5 mins walking distance, whereas 10% of the audited area does not have formal transit stands/stops reachable within 10 minutes walking distance. This data can be used by the authorities to strengthen the overall transit network of the city and make public transport more accessible by building IPT stops to support the bus and train network. The map 10 on next page shows the bus stops and train stations that were audited. Images on the page 23 indicates the difference in infrastructure at various bus stops. There is a need to upgrade some of the existing bus stops with proper signage and seating infrastructure

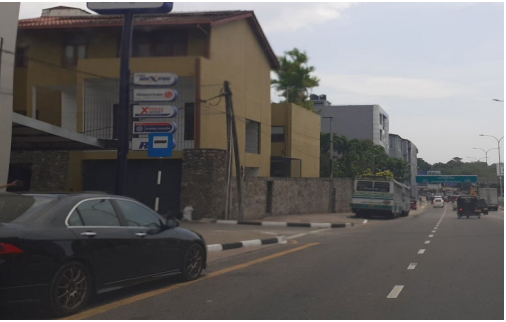
Image 16 showing a bus stop without shelter in CMC area

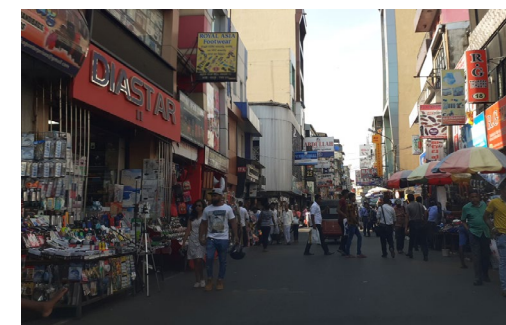
Image 18 showing 2nd cross street with good visibility ratings

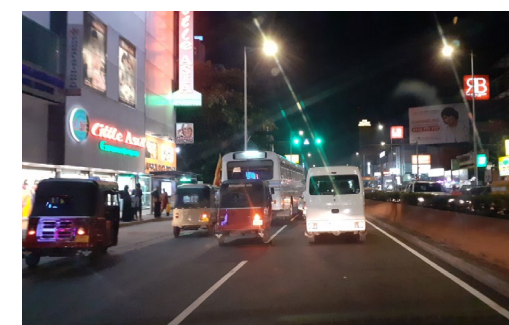
Image 19 showing a stretch on Galle Road rated high in visibility

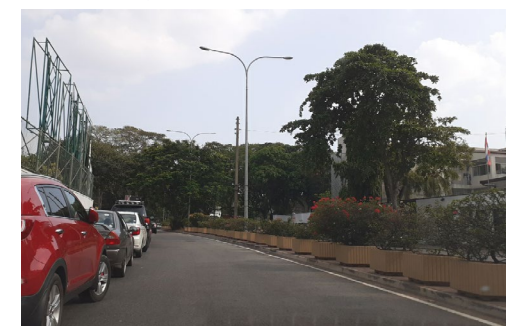
Image 20 showing poor visibility on Sri Marcus Fernando Mawatha road

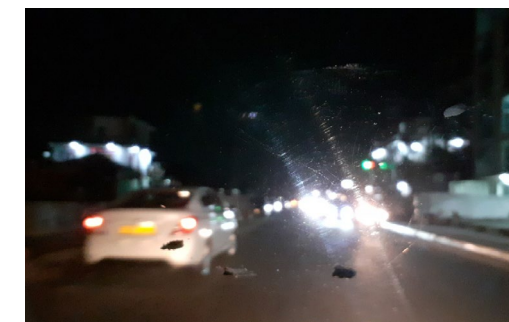
Image 25 showing that there is no street light along the Old Kesbawa Road

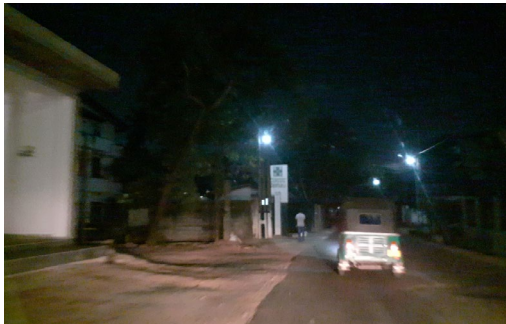
Image 28 showing unpaved path for pedestrians

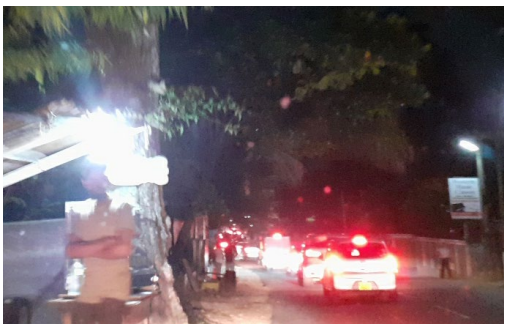
Image 29 showing unpaved path for pedestrians

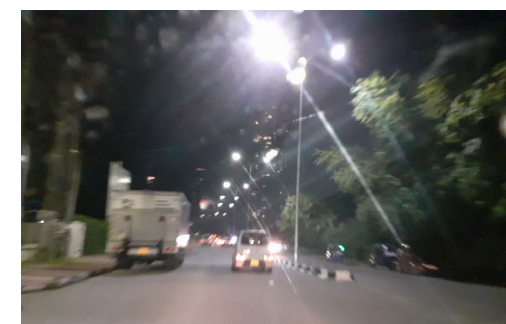
Image 36 showing a stretch of Buthgamuwa Cross Road with poor visibility

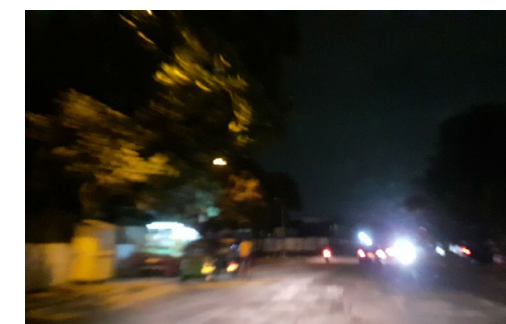
Image 40 showing leaves covering street lights on K Cyril C. Perera Mawatha Road

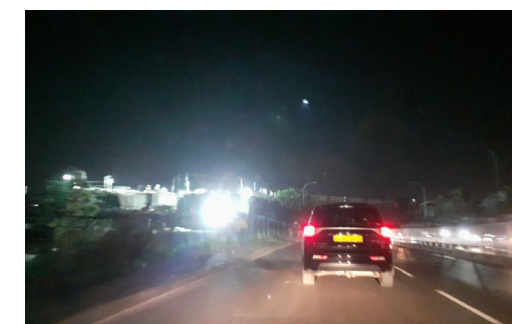
Image 41 showing off street lights on New Elevated Kelani Bridge Road

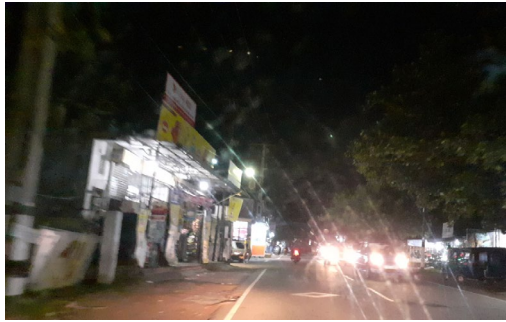
Image 44 showing unpaved pedestrian path on Kolonnawa Anagoda Road

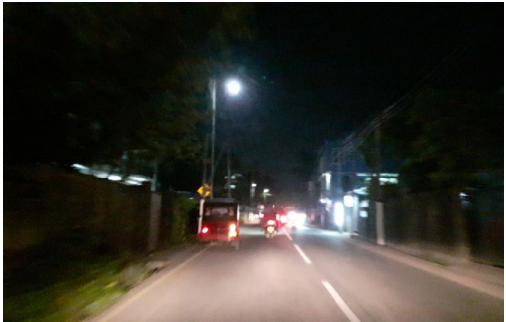
Image 45 showing no pedestrian path on Welikada-Kohilawatte Road

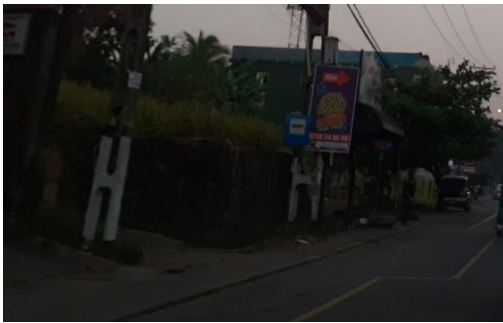
Image 48 showing a bus stop without shelter

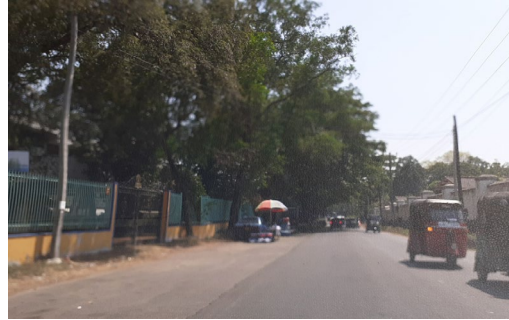
Image 52 showing a stretch of Mulleriyawa Hospital Road with poor visibility

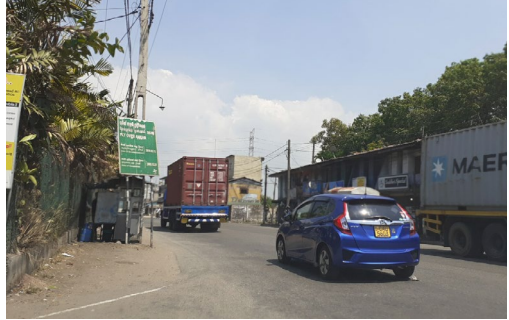
Image 53 showing a stretch of Kaduwela Road with poor visibility

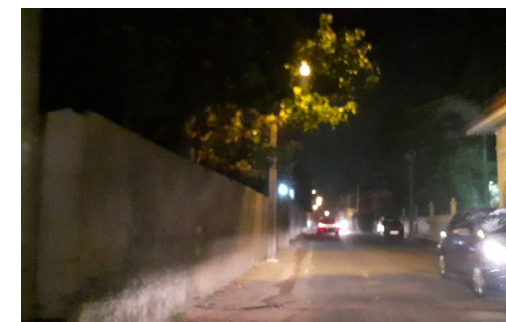
Image 56 showing leaves covering the street light on Anderson Road

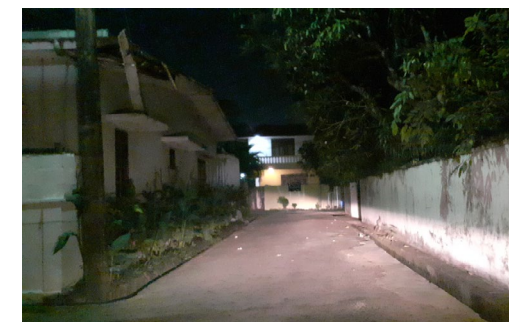
Image 57 showing School Avenue Road with no street light

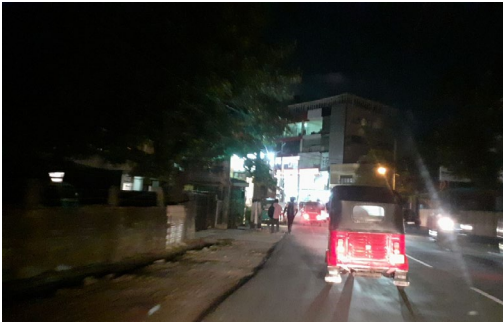
Image 60 showing unpaved pedestrian path on Anagarika Dharamapal Mawatha Road

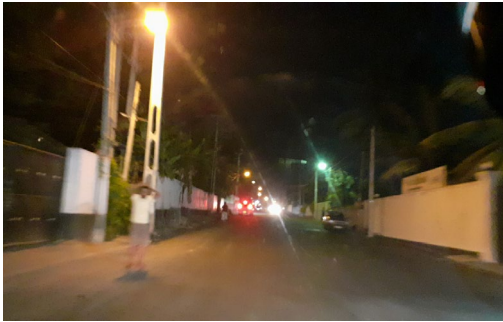
Image 61 showing absence of dedicated pedestrian path on Kawdana Road

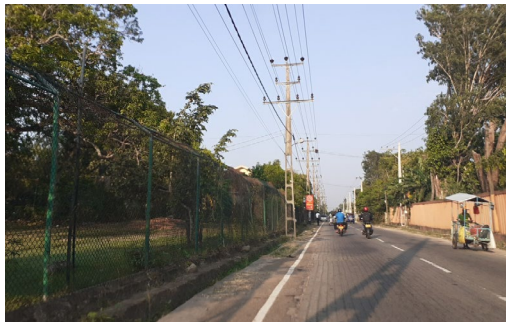
Image 68 showing a stretch on Borupana Road with poor visibility

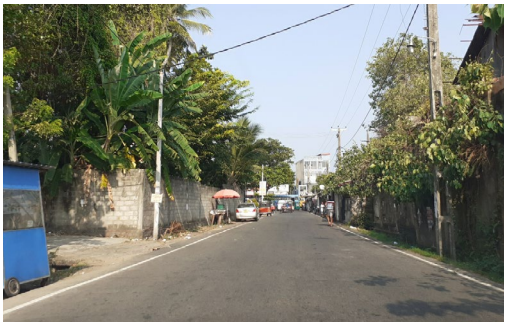
Image 69 showing a stretch with poor visibility on St. Rita's Road

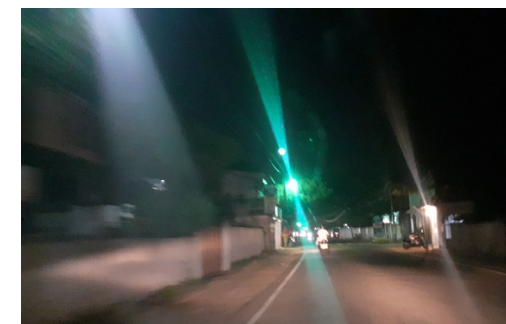
Walkpath parameter indicates whether a person can comfortably walk at a place. This refers to the quality of a pavement or space left for pedestrians along the road. Only 34% of the mapped area has proper pavement to walk. The pie chart on the left indicates the percentage distribution of the ratings of audit points and the map 43 below represents the points geographically. While some of the audited area has been rated good (Images 74 and 75 and map 44 on the next page), more than half of the audit points have been identified as having unpaved or no designated path for pedestrians (Images 76 and 77 on the next page). This geo-located data could be used for up-gradation work and to identify the condition of walkpath in the area.

Image 76 showing unpaved pedestrian path on Koralawella Road

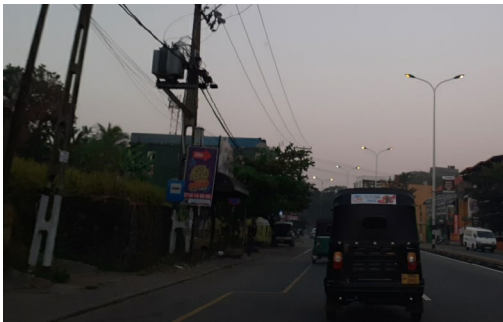
Image 81 showing a bus stop without a shelter

Public Transport refers to the ease of accessing any mode of public transport i.e. rail/bus/taxi/three-wheeler etc and is measured in terms of the distance from the nearest mode. 52% of the mapped area has public transport stands within 5 mins walking distance, whereas 18% of the mapped area has public transport stand within 5-10 min of walking distance and 30% of the audited area does not have formal transit stands/stops reachable within 10 minutes walking distance. This data can be used by the authorities to plan or improve the overall transit network of the city and make public transport more accessible by building IPT stops to support the bus and train network. The map 46 on page 71 shows the bus stops and train stations which were audited. Images on the page 71 indicates the difference in infrastructure at various bus stops. There is a need to upgrade some of the existing bus stops with proper signage and seating infrastructure

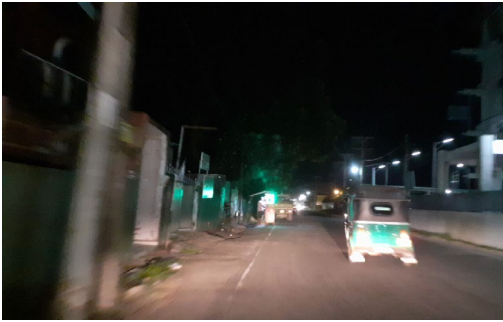
Image 84 showing a stretch with poor visibility on some points on Angulana Station Road

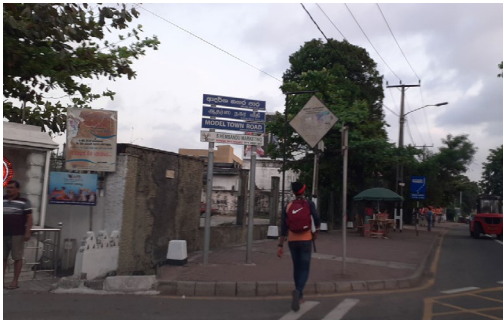
Image 85 showing poor visibility on a stretch on Galle Road

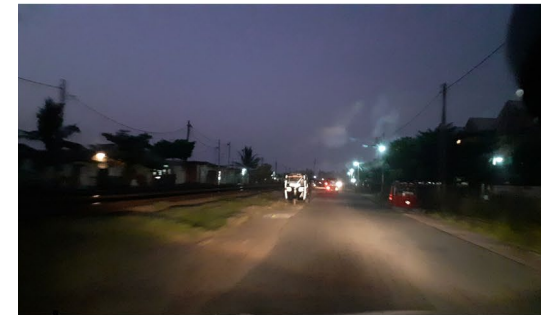
Image 89 showing Raja Mawatha road with poor lighting, walkpath and visibility

As we move down to other councils, these elements are limited to few stretches along this road and other major roads of the council area also lack proper civic infrastructure. This can be seen on Puranappu Raja Mawatha Road and Uyana Road which run parallel to the Galle road in Moratuwa Council area. As seen in the map 56 and images on the next page, Puranappu Raja Mawatha road doesn't have streetlights or proper pavement for the pedestrians along the unhindered railway line that runs along this stretch. The beaches in Moratuwa and Mount Lavinia council areas are on the other side of this railway line, thus making it essential to provide safe walking and crossing areas for people. Building on existing design principle and good practices, an attempt to re-imagine the street can be seen in the image below. Installing streetlights and constructing a proper pavement maintaining a safe distance from the railway line as well as vehicular carriageway would positively impact people's use and perception of the street

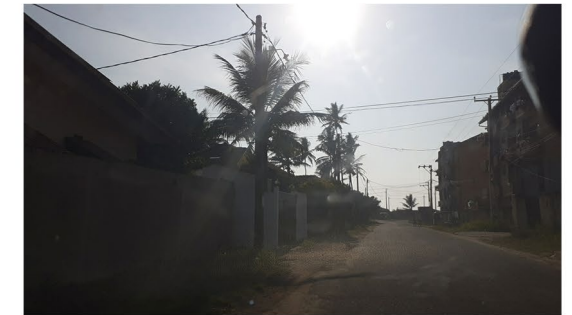
Image 90 showing deserted Raja Mawatha Road

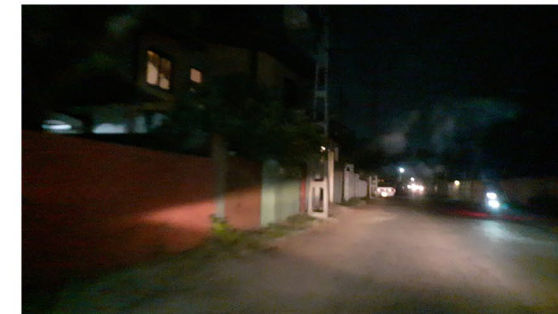
Image 91 showing poor walkpath and visibility on Uyana Road

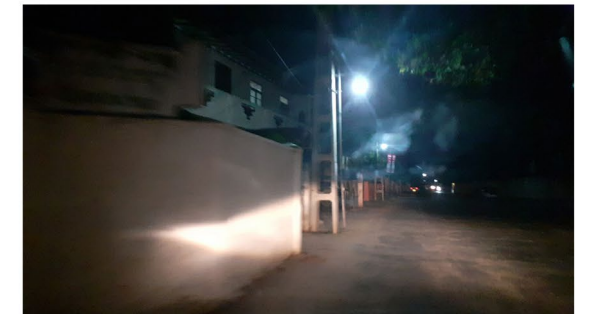
Image 92 showing deserted Uyana Road
